Manhole Inspection Summary

Manhole # S45C2_021MH

Location Address: **3617 Everett St** Cross Street: **E. Pontiac Ave.**

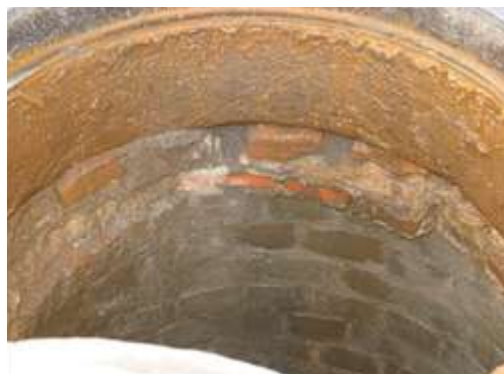
Defect 1

Corbel Material: **Brick** ☐ Parged Type: **Concentric/Eccentric**
Condition: ☐ Sound ☐ Cracked ☐ Root Intrusion ☒ **Loose Brick** ☐ Deteriorated
Infiltration: ☐ None ☐ Joint ☐ Cracks ☒ **Mortar** ☐ Roots ☐ Wall

Loose bricks/infiltration

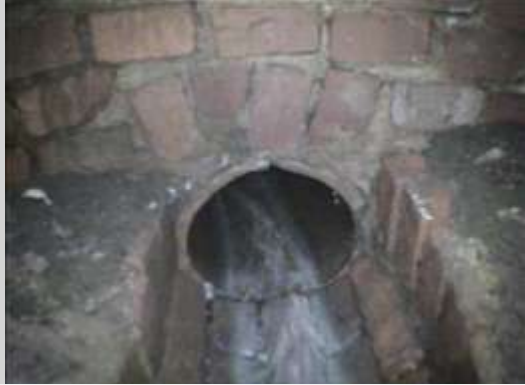
12 O'Clock Outflow

8 in. Circular Gravity Sewer
Pipe Out @ 12 O'Clock

Pipe Height: **10.8** (in.) Rod and Bar (Angled)
Pipe Material: **Clay** ☐ Pipe Lined
Invert Depth: **10.99** (ft.) Flow Characteristics: **Fast**
Deposits: ☒ None ☐ **Mud** ☐ Sludge ☐ **Debris** ☐ Grease
Silt Depth: (in.) Deposits Extent:
Infiltration: **None** Pipe Seal Cond: **Sound**

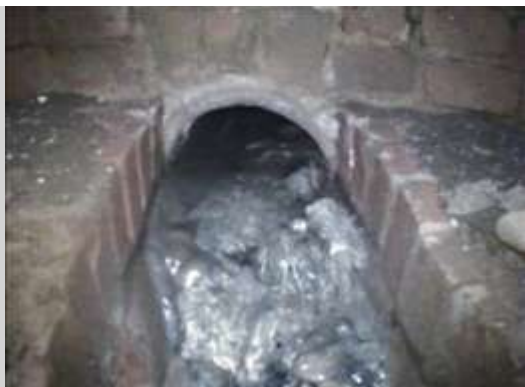
8 O'Clock Inflow

8 in. Circular Gravity Sewer
Pipe In @ 8 O'Clock

Pipe Height: **7.2** (in.) Rod and Bar (Angled)
Pipe Material: **Clay** ☐ Pipe Lined
Invert Depth: **10.39** (ft.) Flow Characteristics: **Slow**
Deposits: ☐ None ☒ **Mud** ☐ Sludge ☒ **Debris** ☐ Grease
Silt Depth: **5** (in.) Deposits Extent: **Light**
Infiltration: **None** Pipe Seal Cond: **Sound**
